COAL MINE SAFETY AND HEALTH  
REPORT OF INVESTIGATION

Fatal Roof Fall Accident  
August 20, 2003

Cardinal Mine  
Warrior Coal, LLC  
Manitou, Hopkins County, Kentucky  
I.D. No. 15-17216

Release Date: October 14, 2003

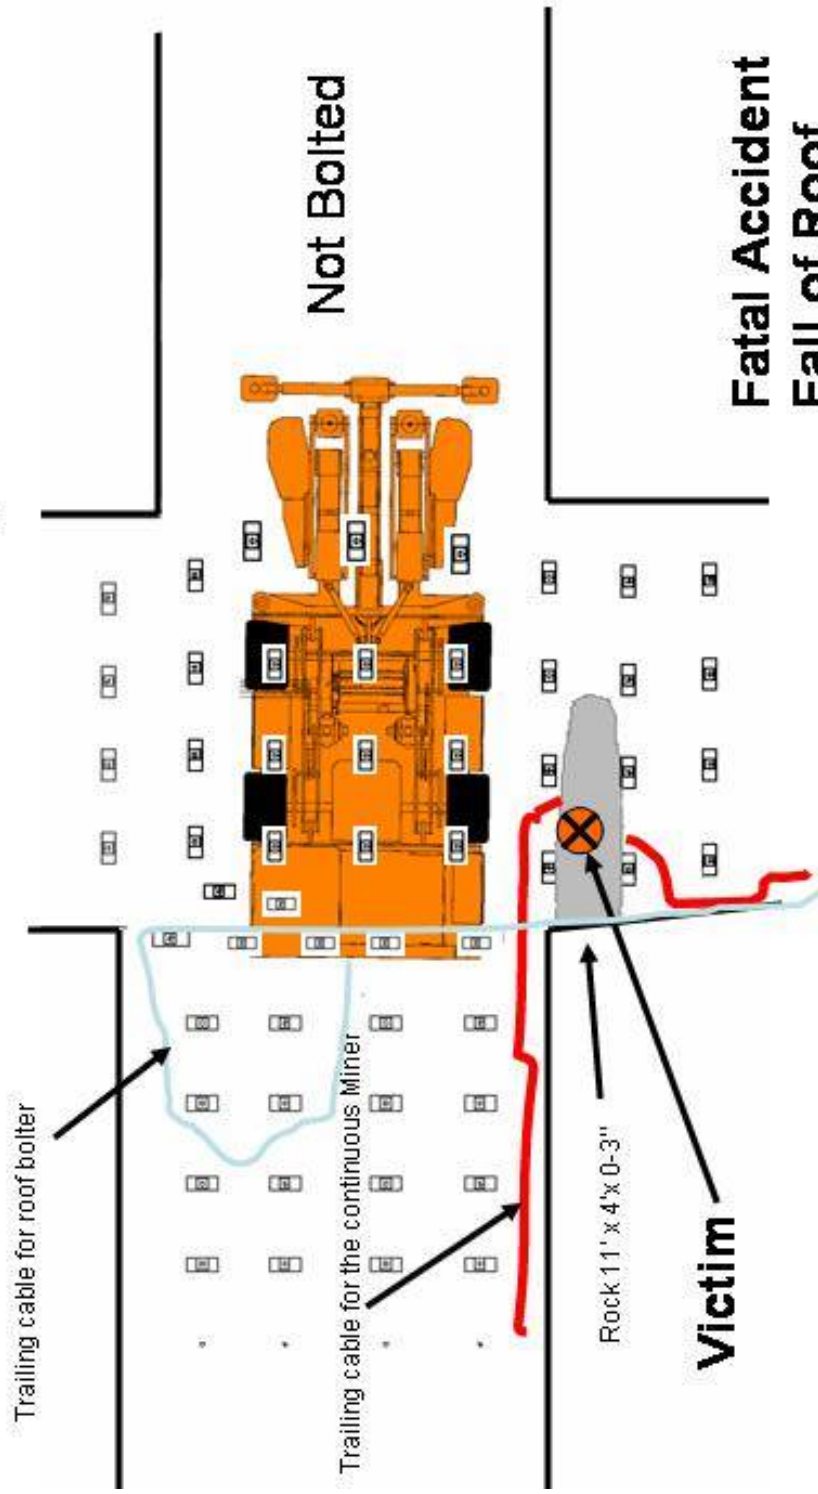
## Face of #6 Entry

The accident occurred while Adams was helping relocate the trailing cable for the right side continuous mining machine to the opposite side of the No. 6 entry. As Adams bent over to pick up the miner cable, a rock measuring 11 feet long by 4 feet wide by 0 to 3 inches thick fell from between two rows of roof bolts. The rock struck Adams, forcing him face down to the mine floor resulting in his death.

The accident occurred near the outby edge of the last open crosscut in the No. 6 entry. At the accident site, mining height was 7 feet and the entry width averaged 19 1/2 feet. The slab that struck the victim fell from between bolt rows and extended outward from the left rib to the center of the entry. The rock was approximately 11 feet long, 4 feet wide, and 0 to 3 inches thick and composed of thinly bedded, brittle shale. The fallen material was comprised of several pieces that were estimated to weigh a combined total of 1,600 pounds. The fall cavity was bounded by several steeply angled slickensides and intersected on the inby side by a tight, vertical joint. Bolt spacings adjacent to the fall were within roof control plan specifications.

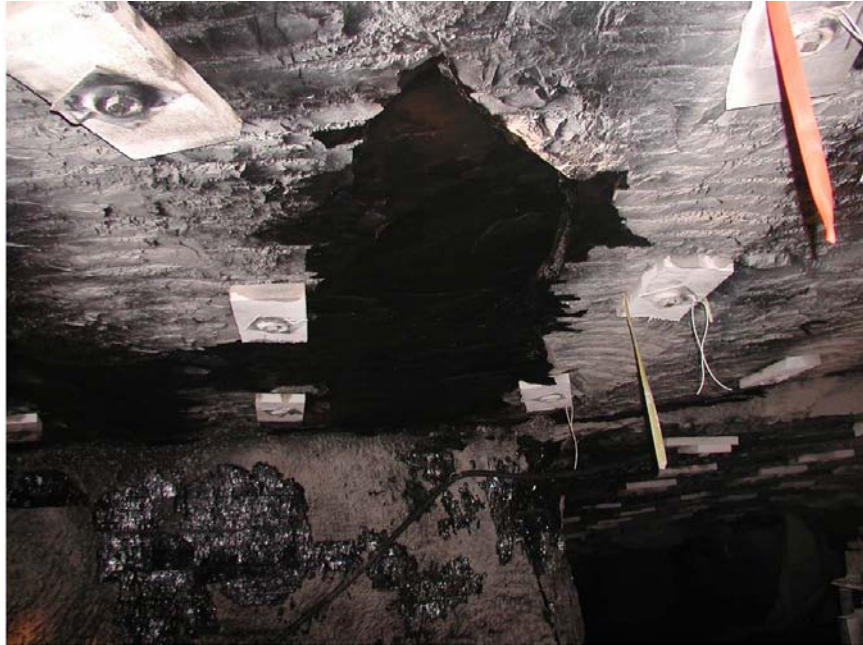
The direct cause of the accident was rock falling from between the rows of permanent roof support. The falling material consisted of several pieces that were estimated to weigh a combined total of 1,600 pounds. The fall cavity was bounded by several steeply angled slickensides and intersected on the inby side by a tight, vertical joint. Bolt spacing adjacent to the fall was within roof control plan specifications.

Roof and rib conditions on the section generally were good. Pillar spalling was typically limited to pillar corners and roof damage was not widespread. Slickensides, bedding planes, and localized cutter roof conditions contributed to instability of the slab at the accident site. The cutter roof damage was present near the roof/rib interface in the form of shallow, stress induced failures along bedding planes. Similar shallow cutter roof damage was observed at inby pillar corners in several other locations on the section.

**Photo 1: Figure 1 Roof cavity from where the 11'x 4'x 0-3' rock fell.**

Corrective Actions: Through revisions to the approved roof control plan, the spacing of the permanent roof bolts was changed from four feet wide and five feet on center to three and one half feet wide and four and a half feet on center. The size of the wooden headers positioned between the six inch by six inch roof bolt plates and the mine roof was increased from eighteen inches in length to twenty inches in length. Reducing the area between the roofbolt spacing across the entry and between the advancing rows of roof support reduces the likelihood in addition to the size of gob falling from between the permanent roof support. In addition, all underground employees were retrained to improve their recognition of roof conditions which require further actions

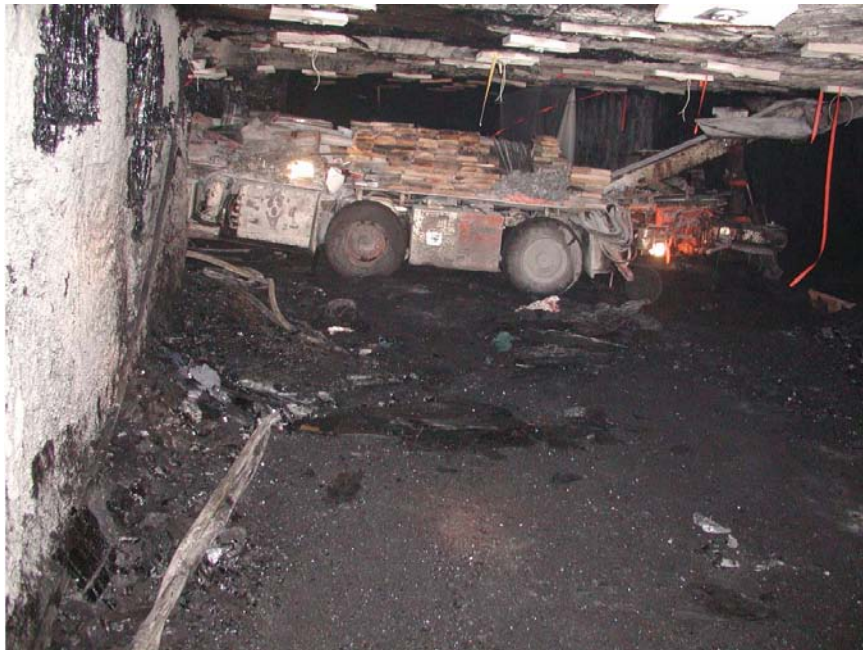
**Photo 2: Position of roof bolting machine and trailing cable outby the working face of the #6 entry in the last open crosscut.**
